NASA
LANGLEY RESEARCH CENTER

PROJECT FIRE
INTEGRATED POST FLIGHT
EVALUATION REPORT

FLIGHT NO. 1

REPORT NO. GDA | BKF64-018

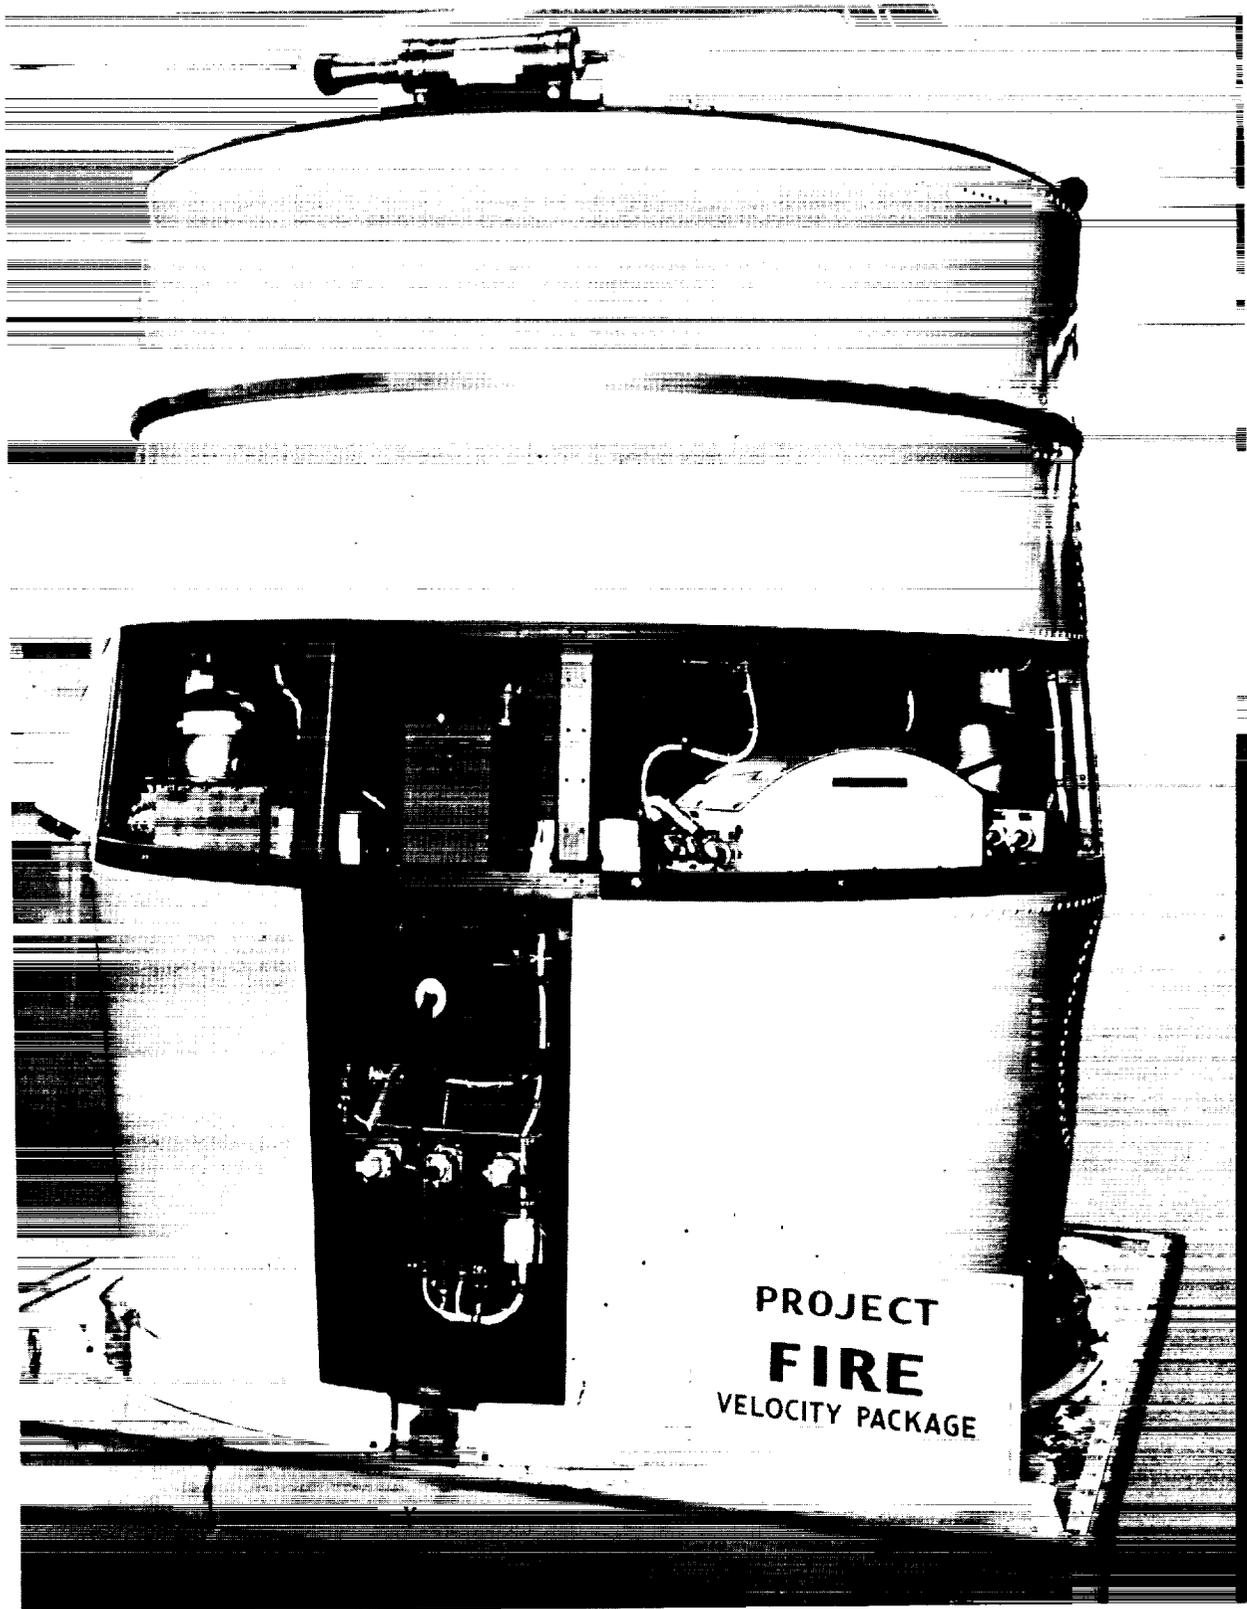
VELOCITY PACKAGE PERFORMANCE
FIGURE NO. 6-1-5
INTEGRATED REPORT NO. GDA/BKF64-018
LTV/A REPORT NO. 3-30000/4R-75
INTRODUCTION

VELOCITY PACKAGE SHELL ASSEMBLY

The basic structure of the Velocity Package consists of two circular shells, one within the other. A metalite shelf located between the outer and inner shell sections provides support for the major part of the V/P equipment. A Velocity Package Adapter provides the structural and electrical interface between the Velocity Package and the Launch Vehicle and the Reentry Package Adapter provides the structural and electrical interface between the Velocity Package and the Reentry Package. Propulsion for the Velocity Package is provided by an ANTARES II A5 (ABL X-259) solid propellant rocket motor, manufactured by the Allegany Ballistics Laboratory. A heat shroud, manufactured for LTV/A by the Douglas Aircraft Corporation, protects the Spacecraft from aerodynamic heating during the boost ascent. Major components of the Spacecraft are shown in Figure 6-1-3 and a cutaway view is shown in Figure 6-1-4. The Velocity Package shell assembly and the Velocity Package with the heat shroud installed are shown in Figures 6-1-5 and 6-1-6, respectively. The Velocity Package also includes a guidance system for maintaining stability and control, a telemetry system for transmitting flight data, and an ignition/ destruct system.
